Debris/Ice/TPS Assessment And Photographic Analysis For Shuttle Mission STS-43

September 1991

DEBRIS/ICE/TPS ASSESSMENT
AND
PHOTOGRAPHIC ANALYSIS
OF
- SHUTTLE MISSION STS-43

August 2, 1991

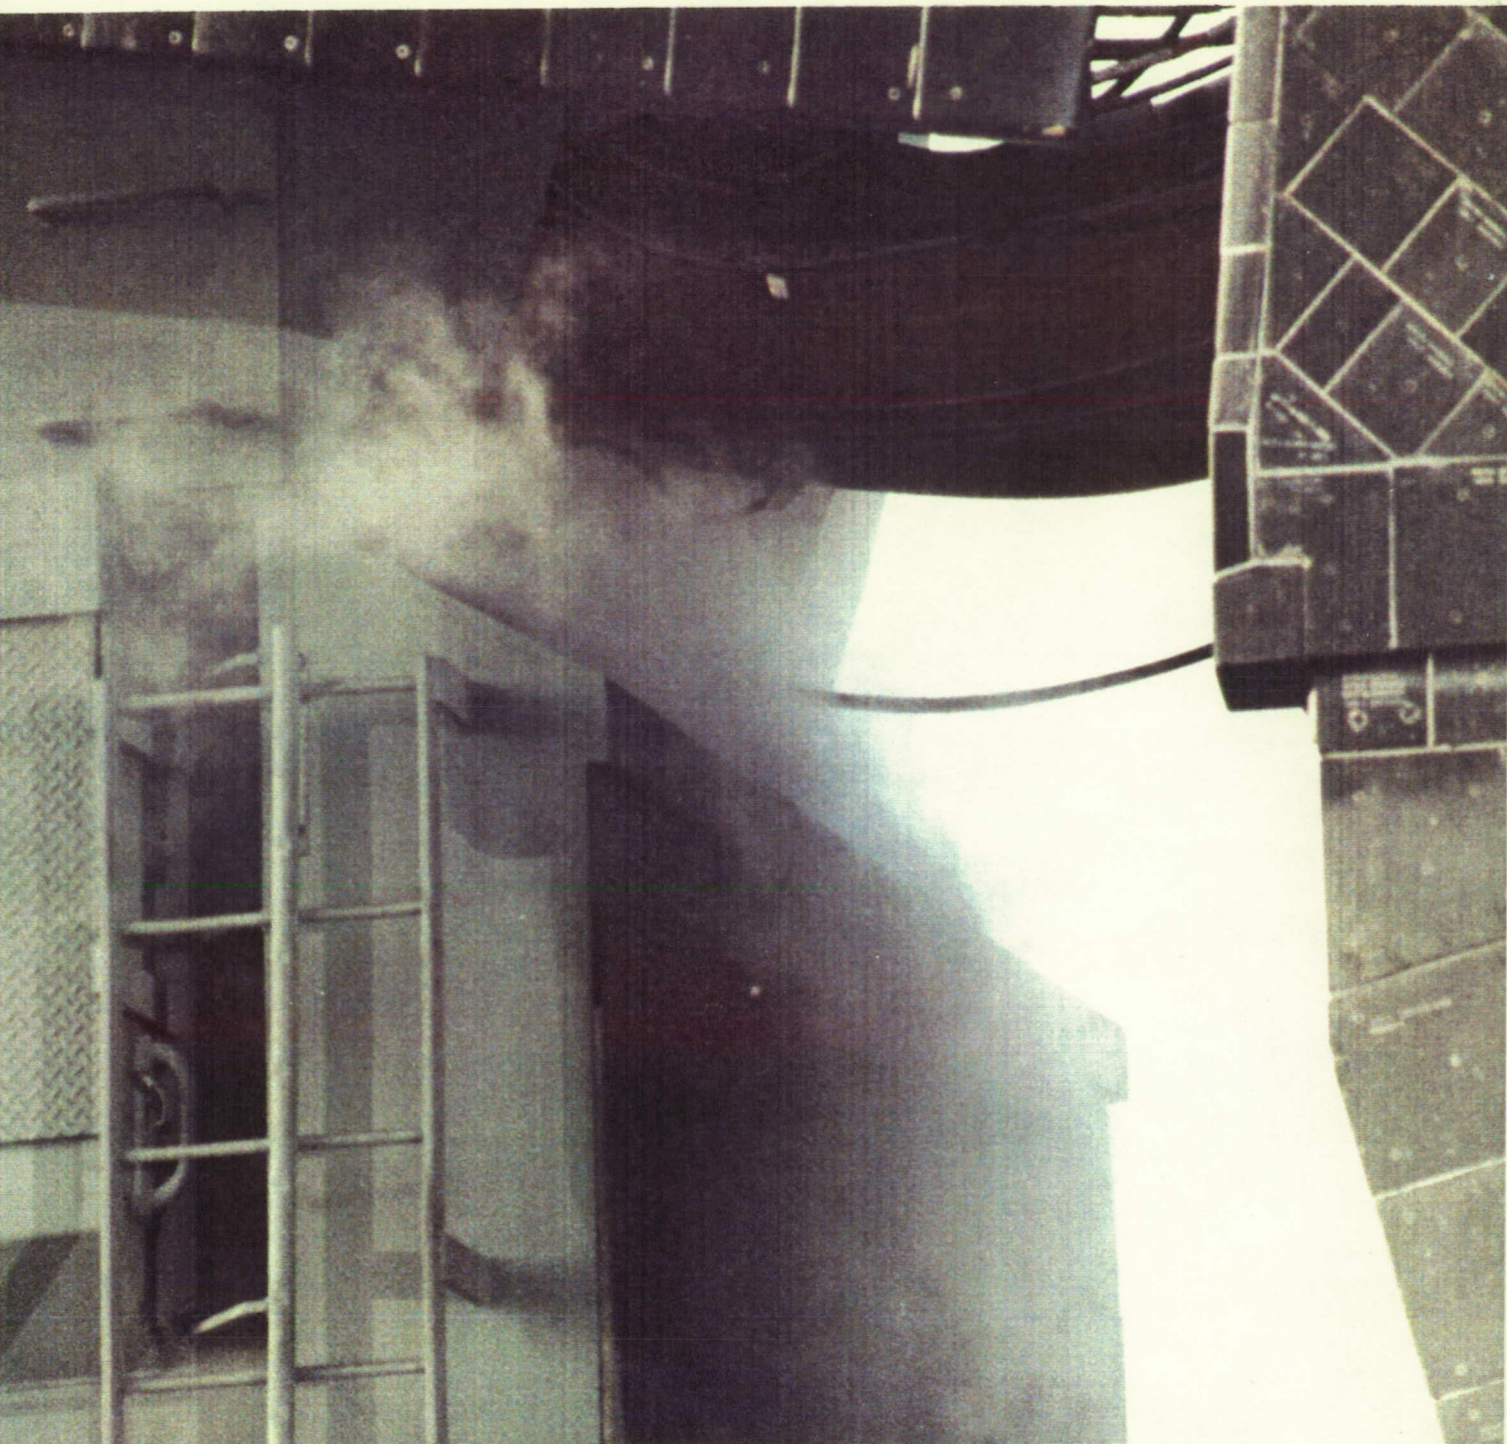
Excessive gaseous oxygen vapors emanated from the open door of the LO2 TSM and a facility IPR was taken against a suspected liquid oxygen leak inside the TSM

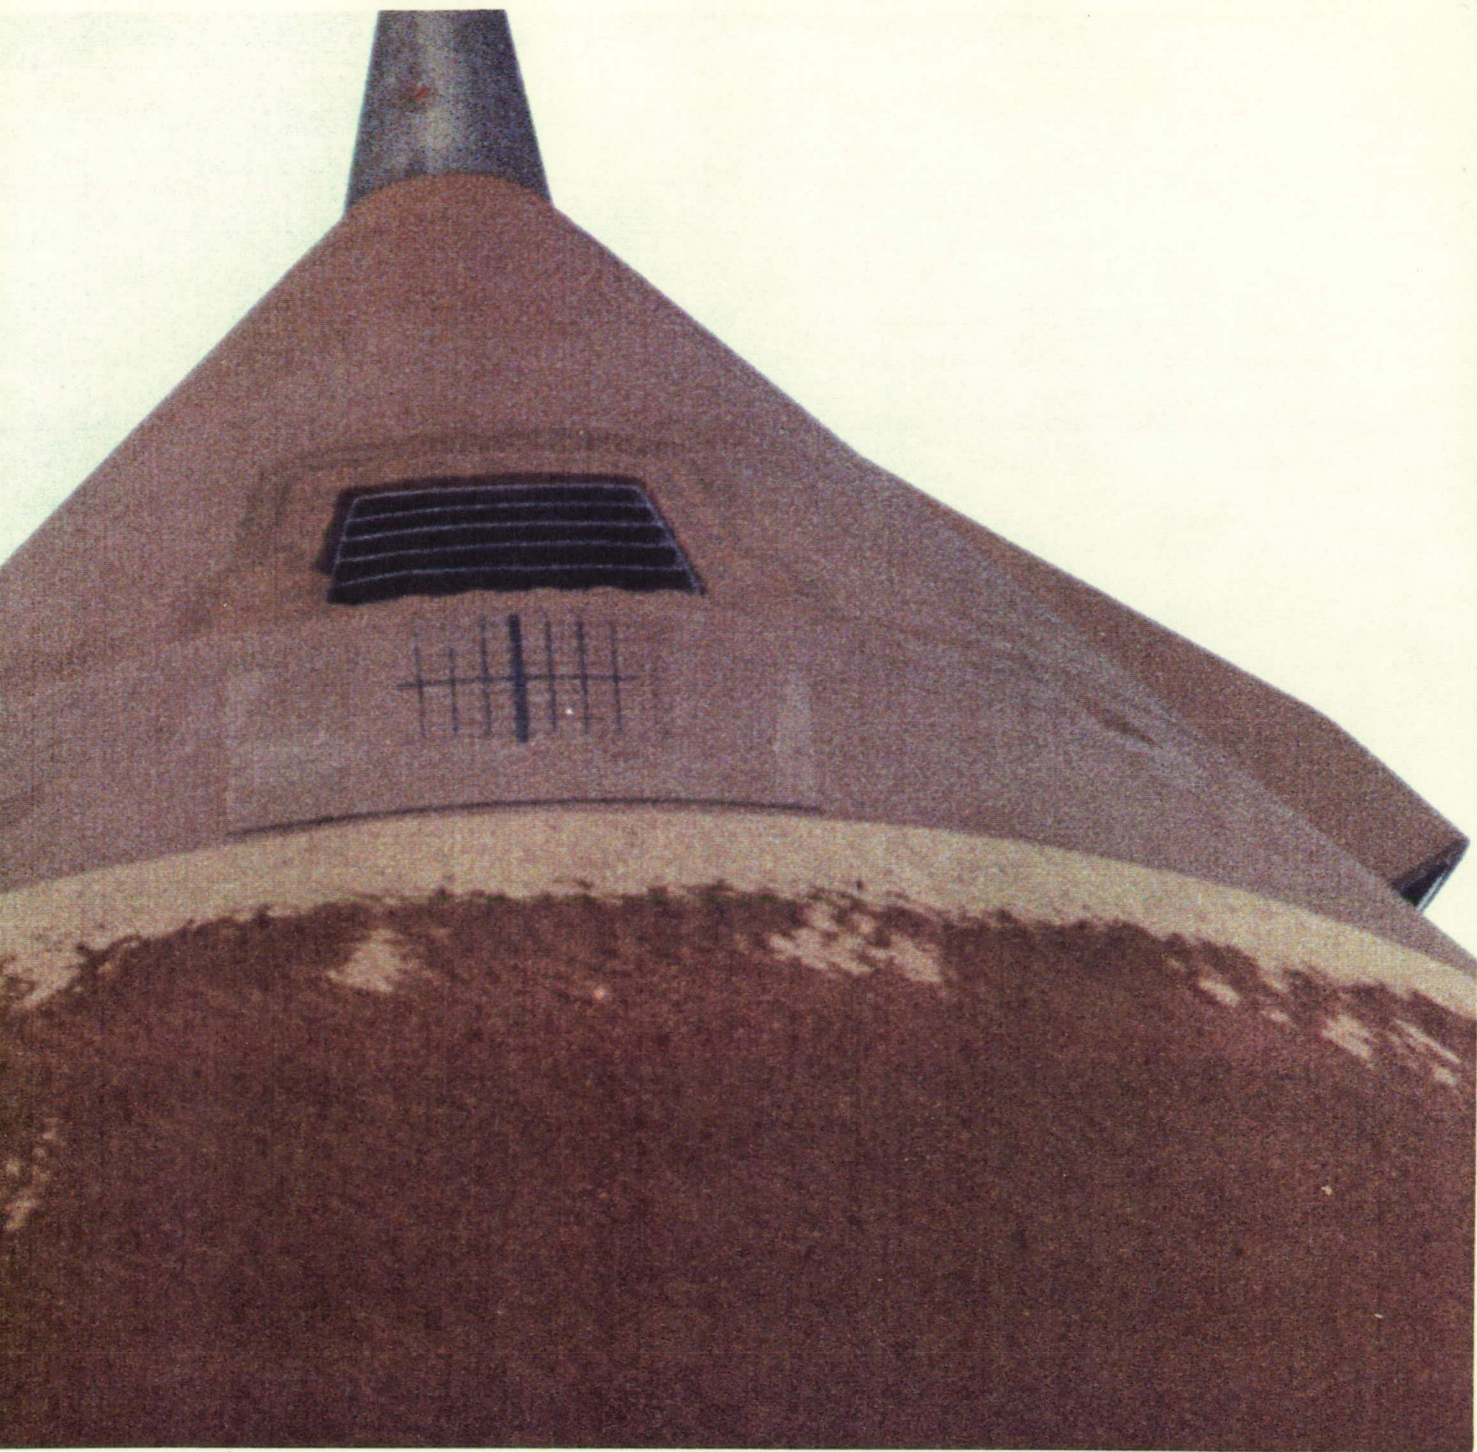
The tumble valve cover was intact. There were no anomalies on the -Y side of the nosecone, fairing, louver, and footprint area. The nosecone +Y side was not accessible for inspection.

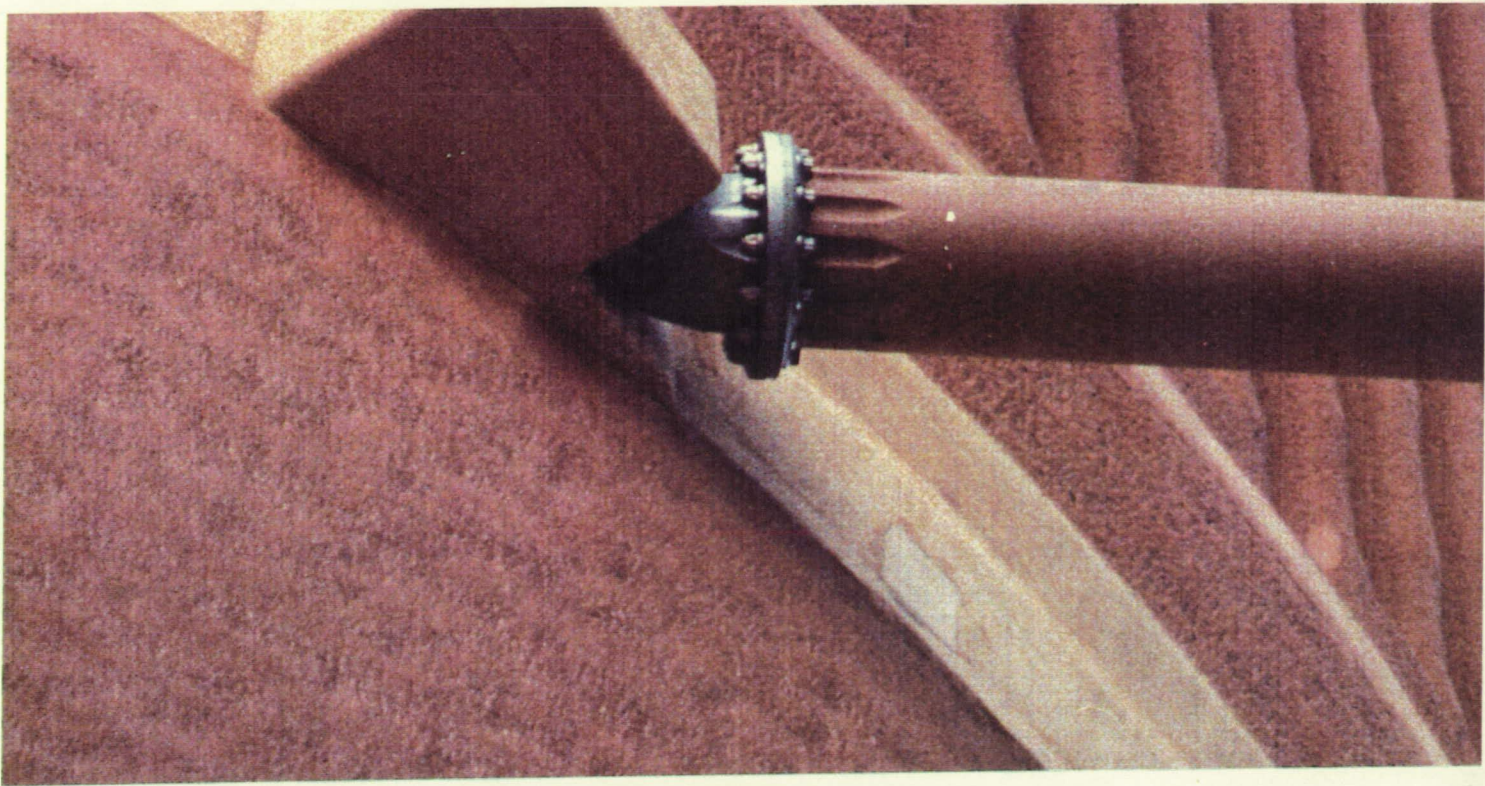
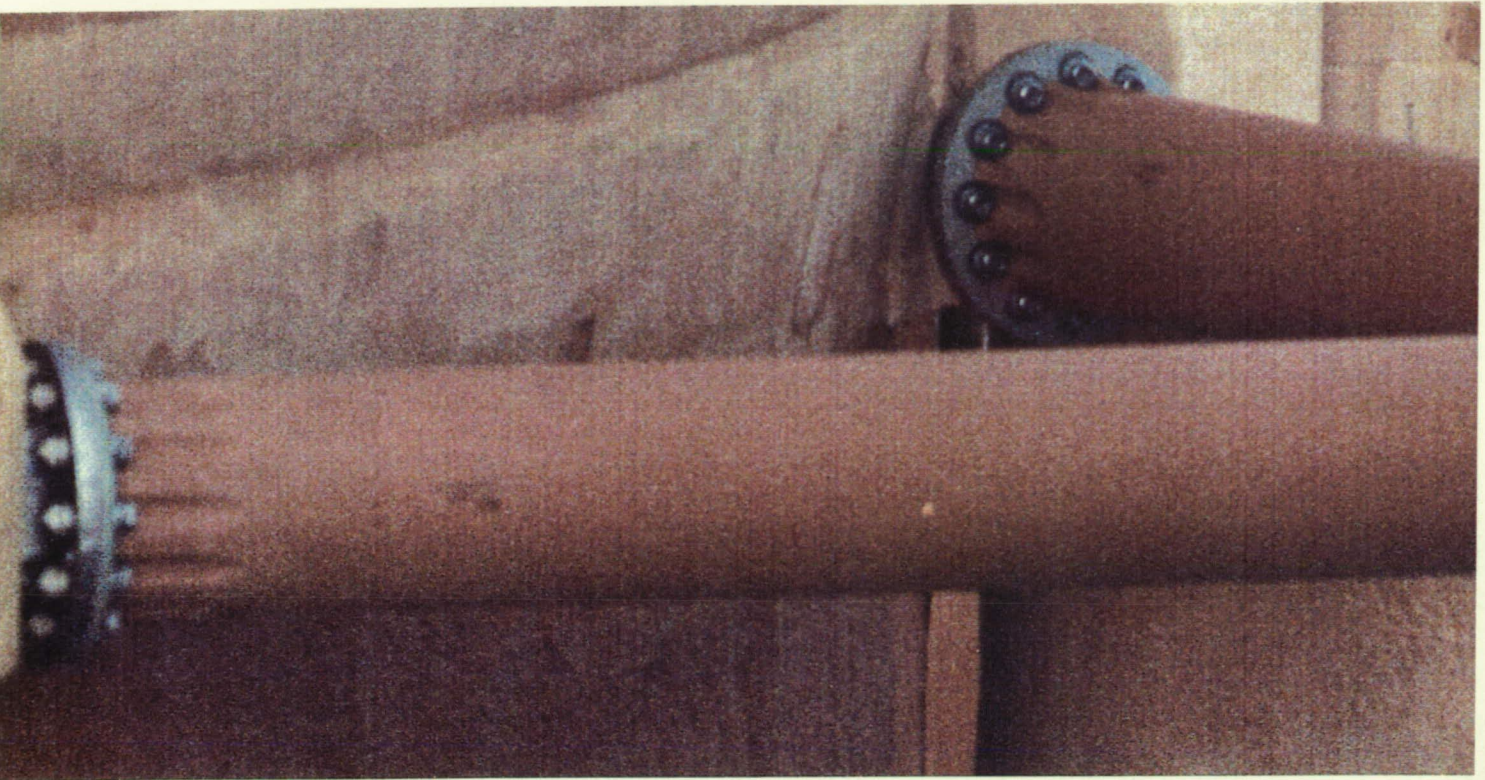
Both bipod jack pad closeouts were intact after cryo load

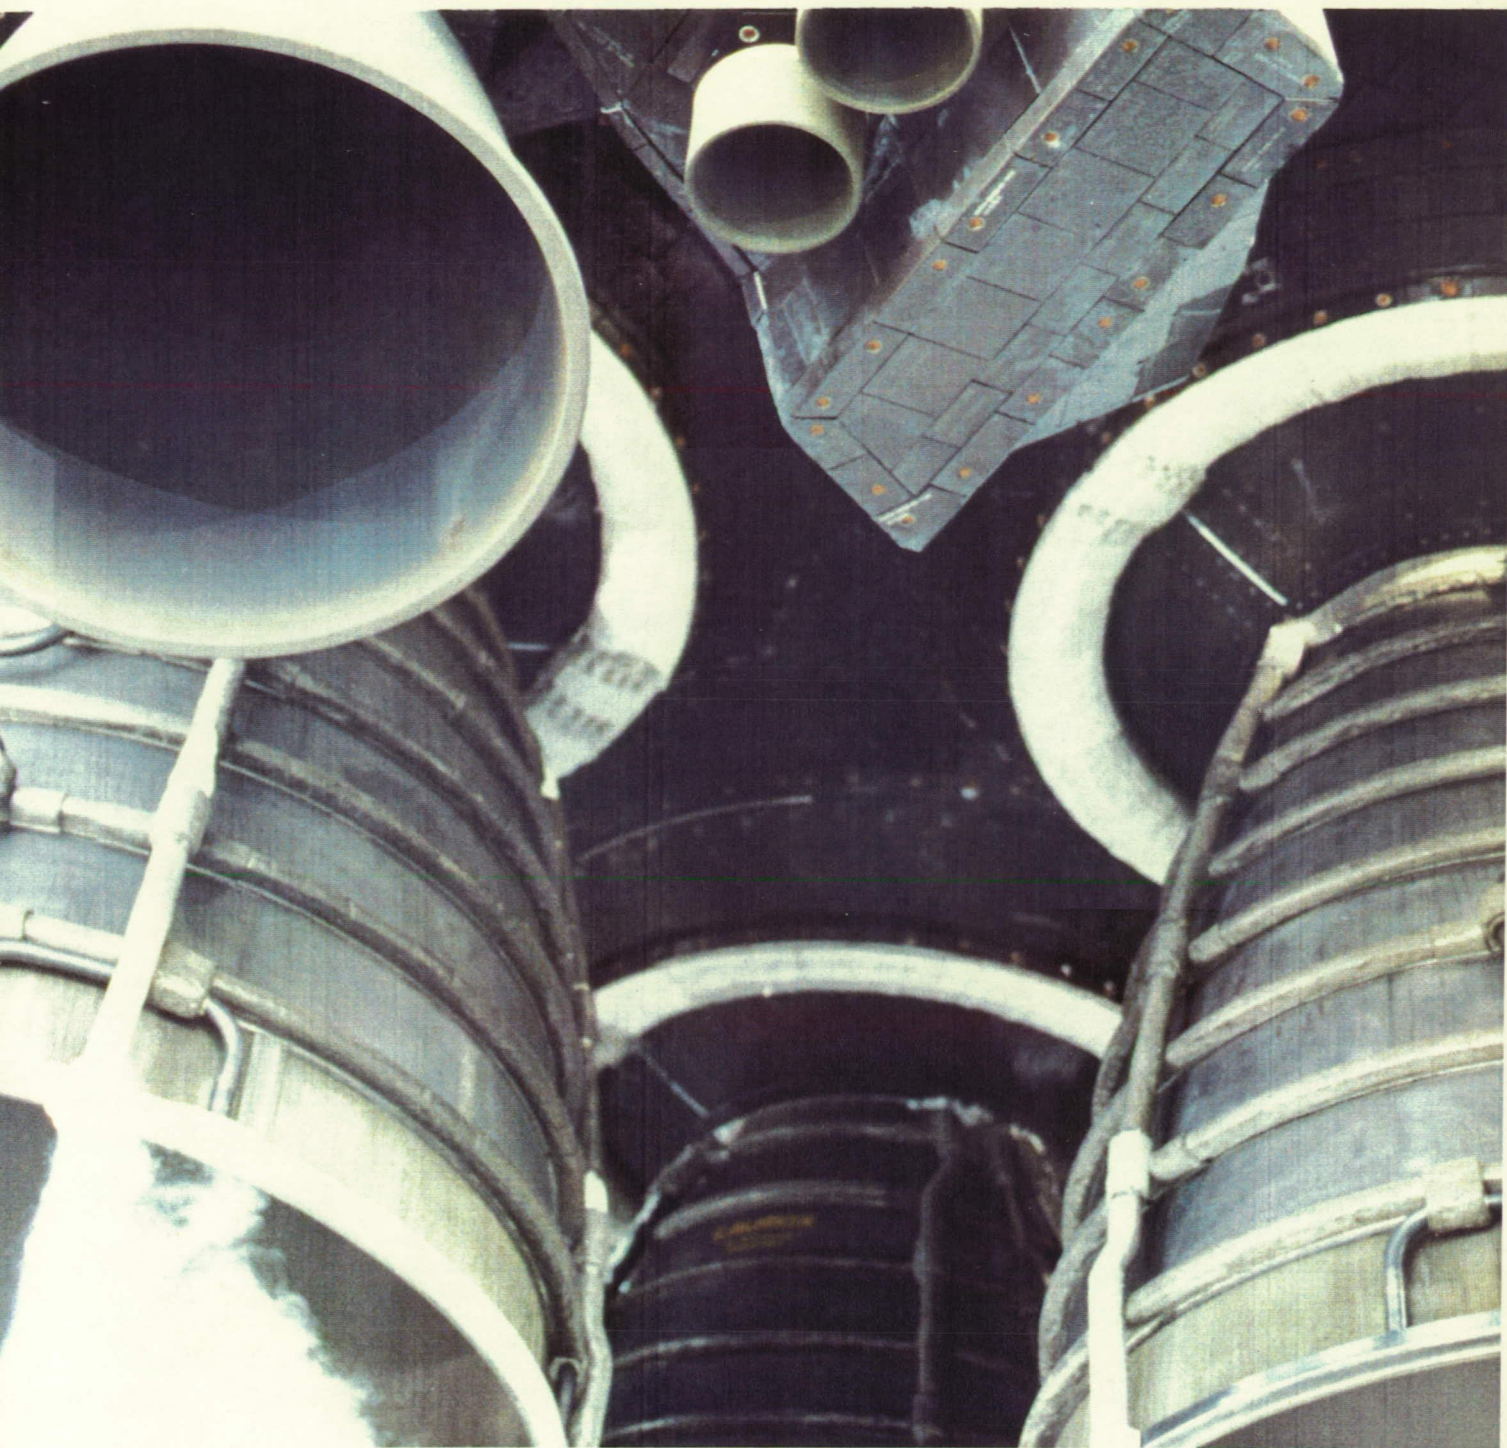
Overall view of the SSME cluster and RH OMS nozzle. Some ice/frost had accumulated at the SSME #1 and #2 heat shield-to-nozzle interfaces.

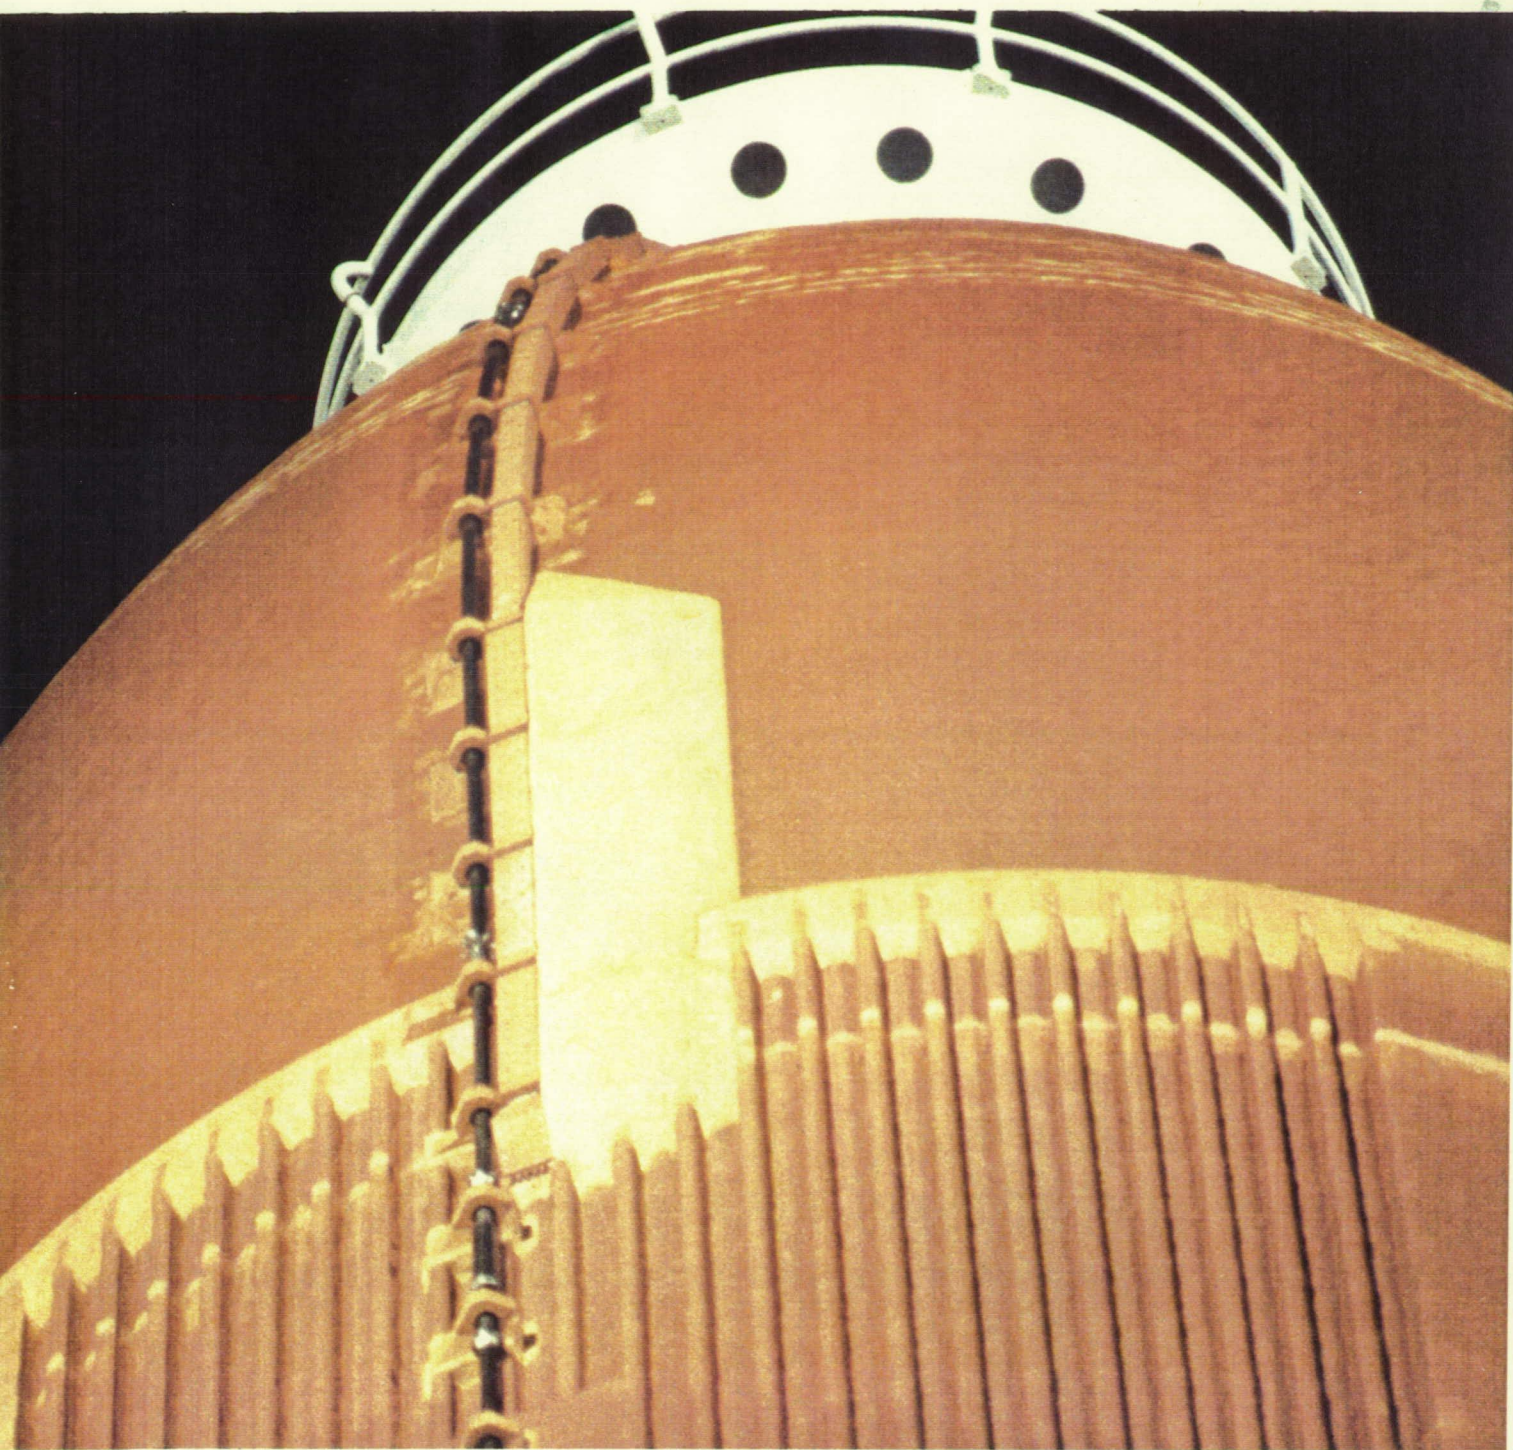
Very light condensate, but no ice or frost, was present on the L02 tank barrel TPS acreage. There was no ice/frost or condensate on the L02 tank ogive. There were no TPS anomalies.

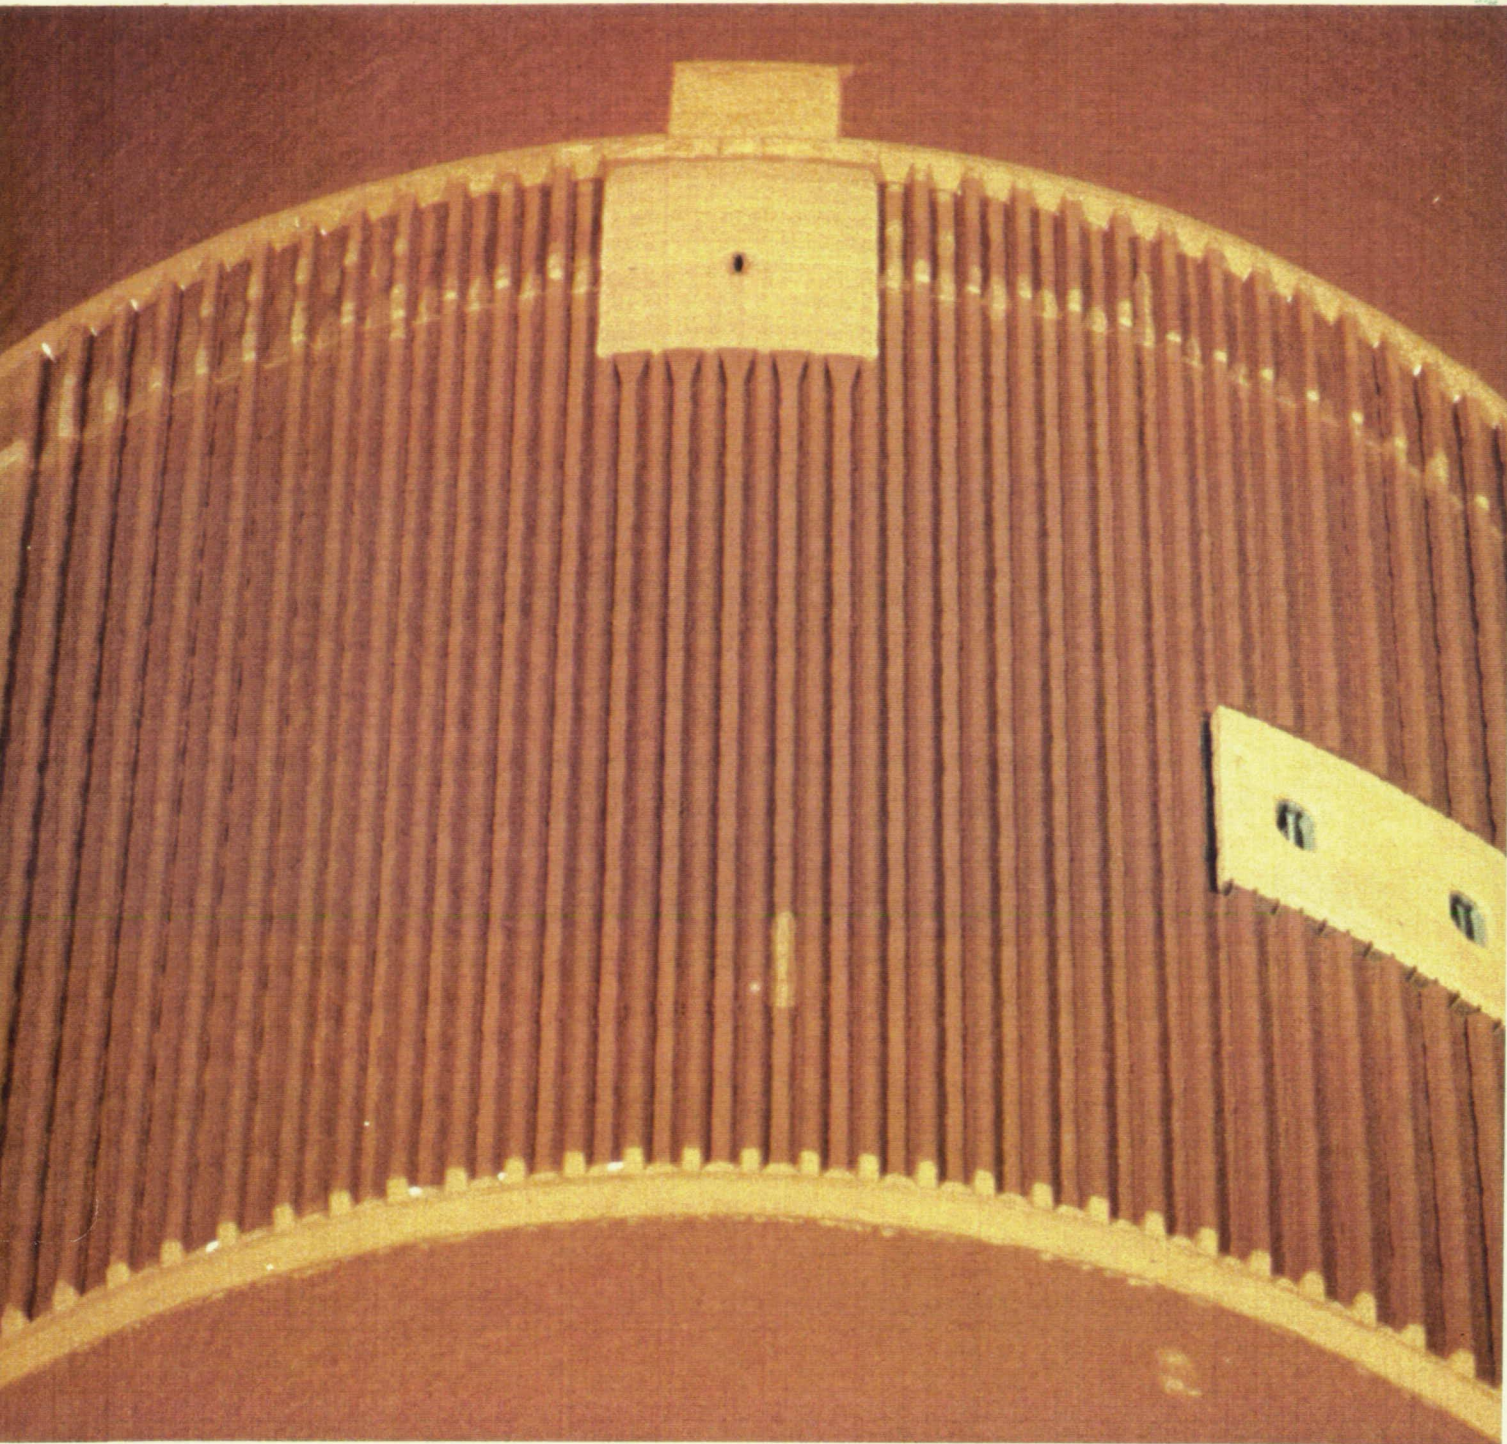
The intertank TPS acreage was wet with run-off condensate. There were no TPS anomalies. Numerous small scattered frost spots appeared in the stringer valleys at both LH2 and LO2 tank -Z flanges - an acceptable condition per NSTS-08303.

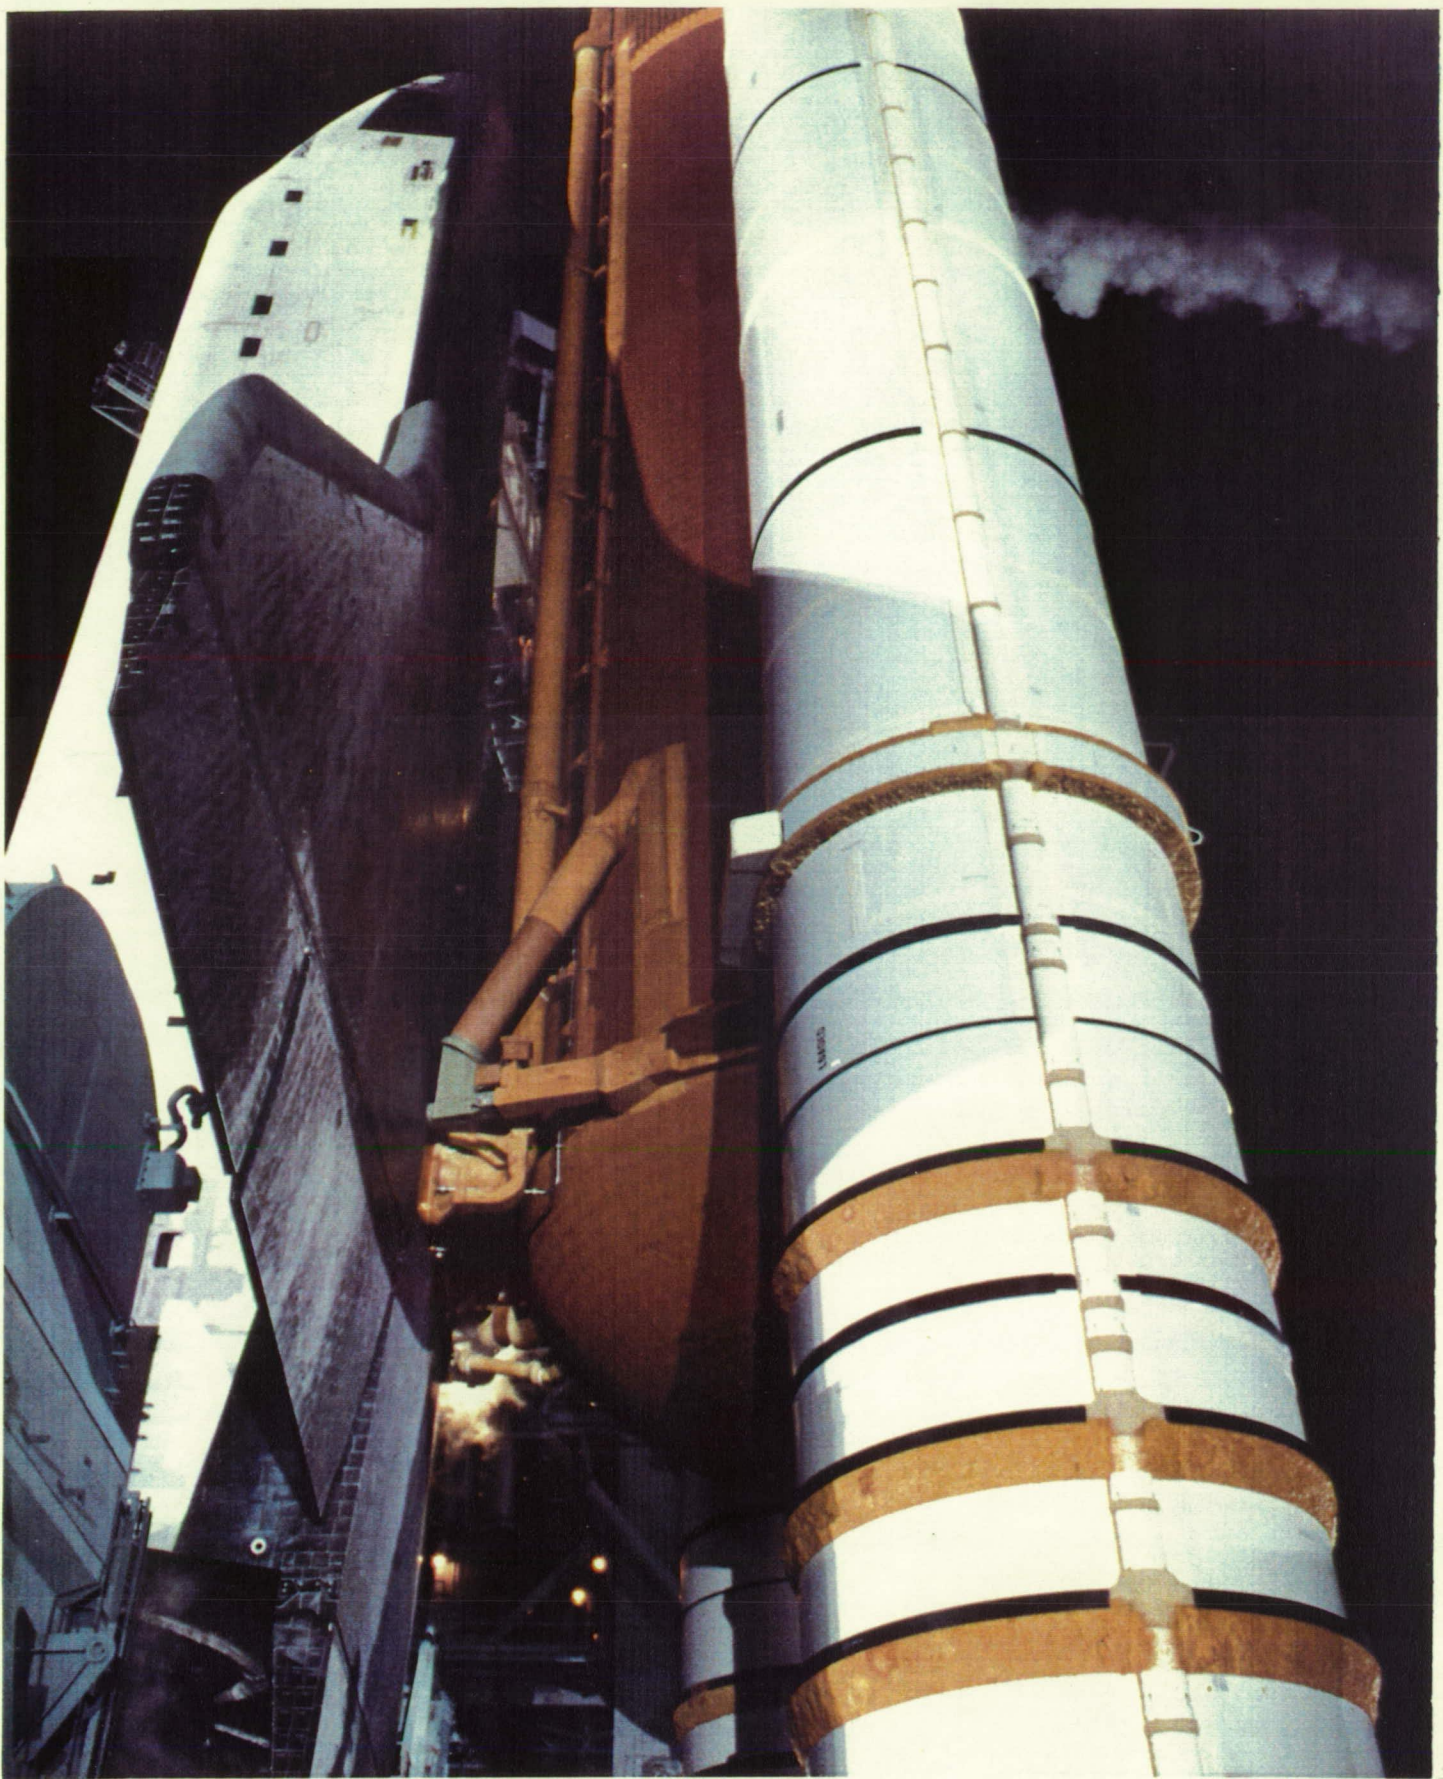
The LH2 tank and aft dome TPS acreage were covered with a moderate amount of condensate. There were no TPS anomalies or ice/frost accumulations on the acreage.

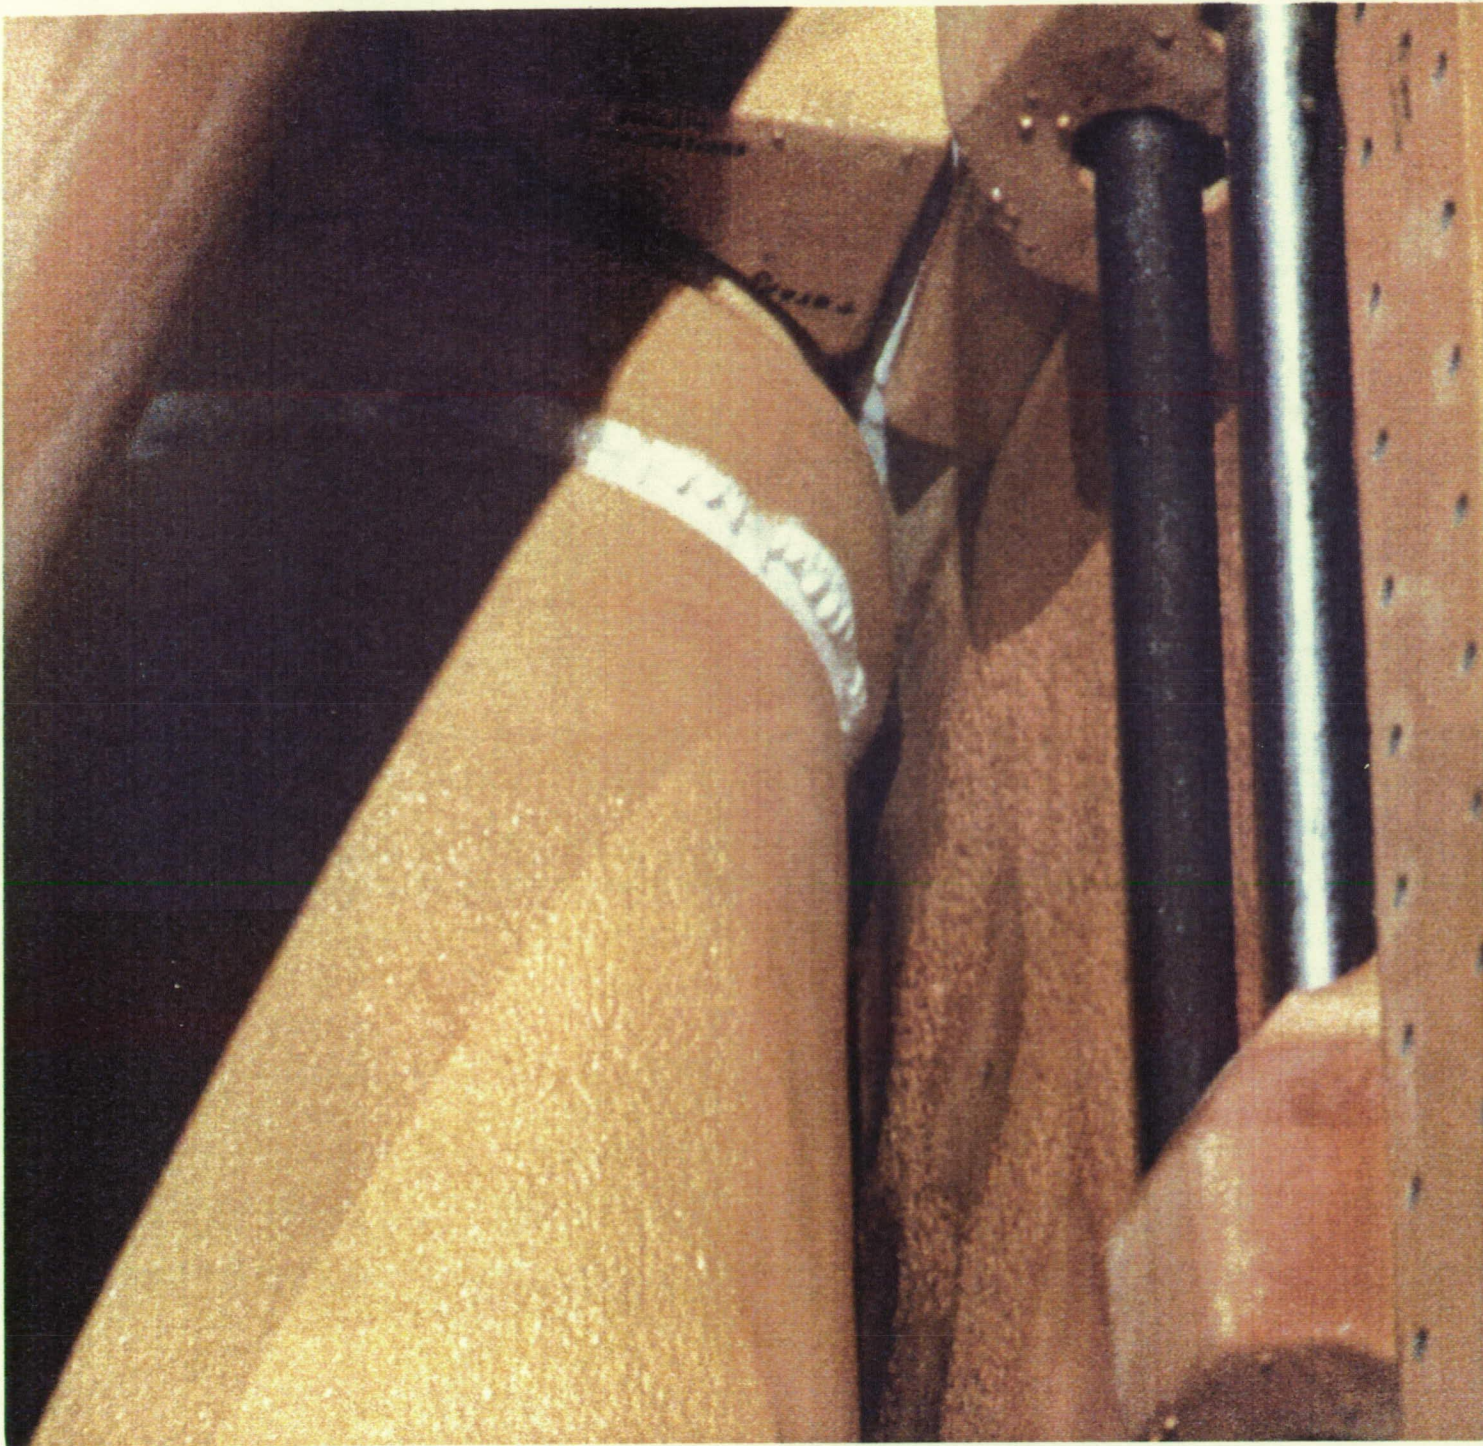
Typical amounts of hard, crusty ice were present in all
L02 feedline bellows and support brackets

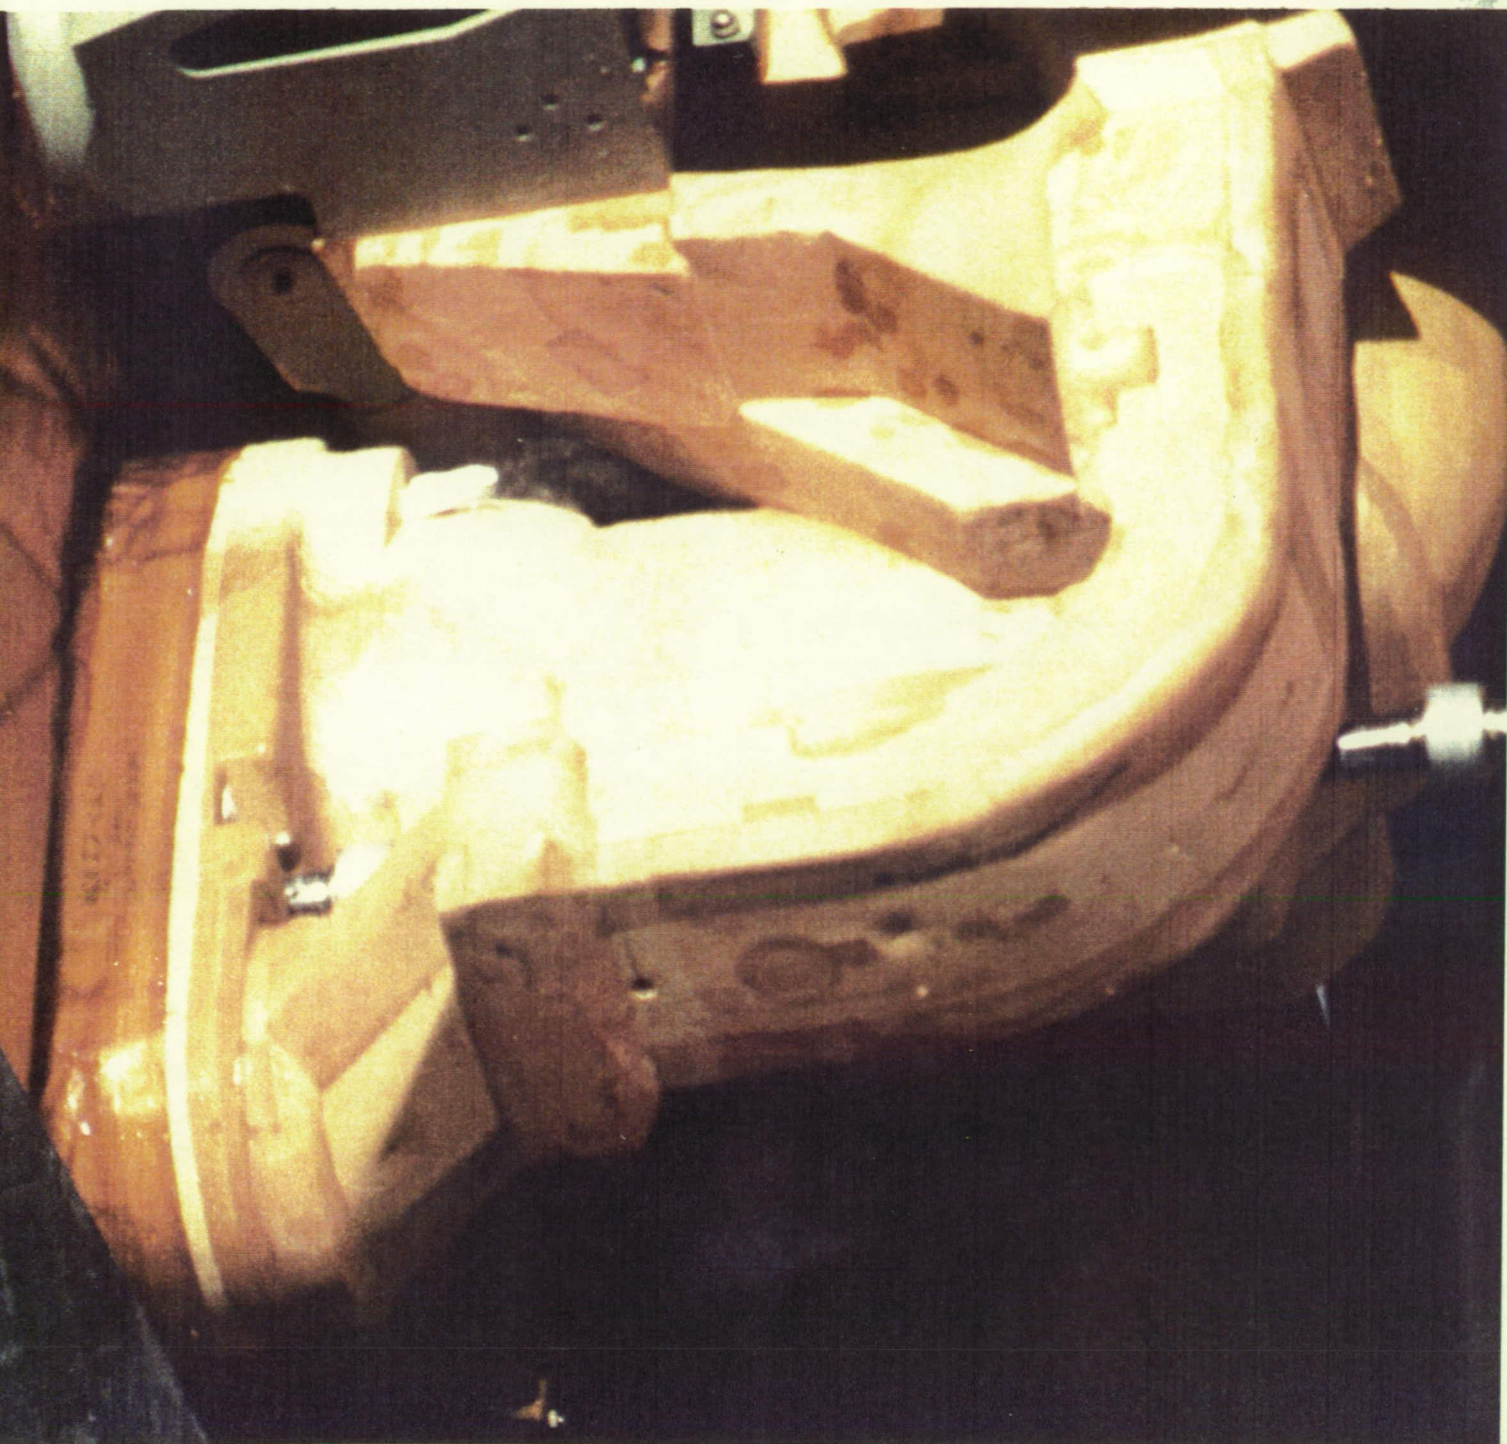
There were no anomalies on the L02 ET/ORB umbilical

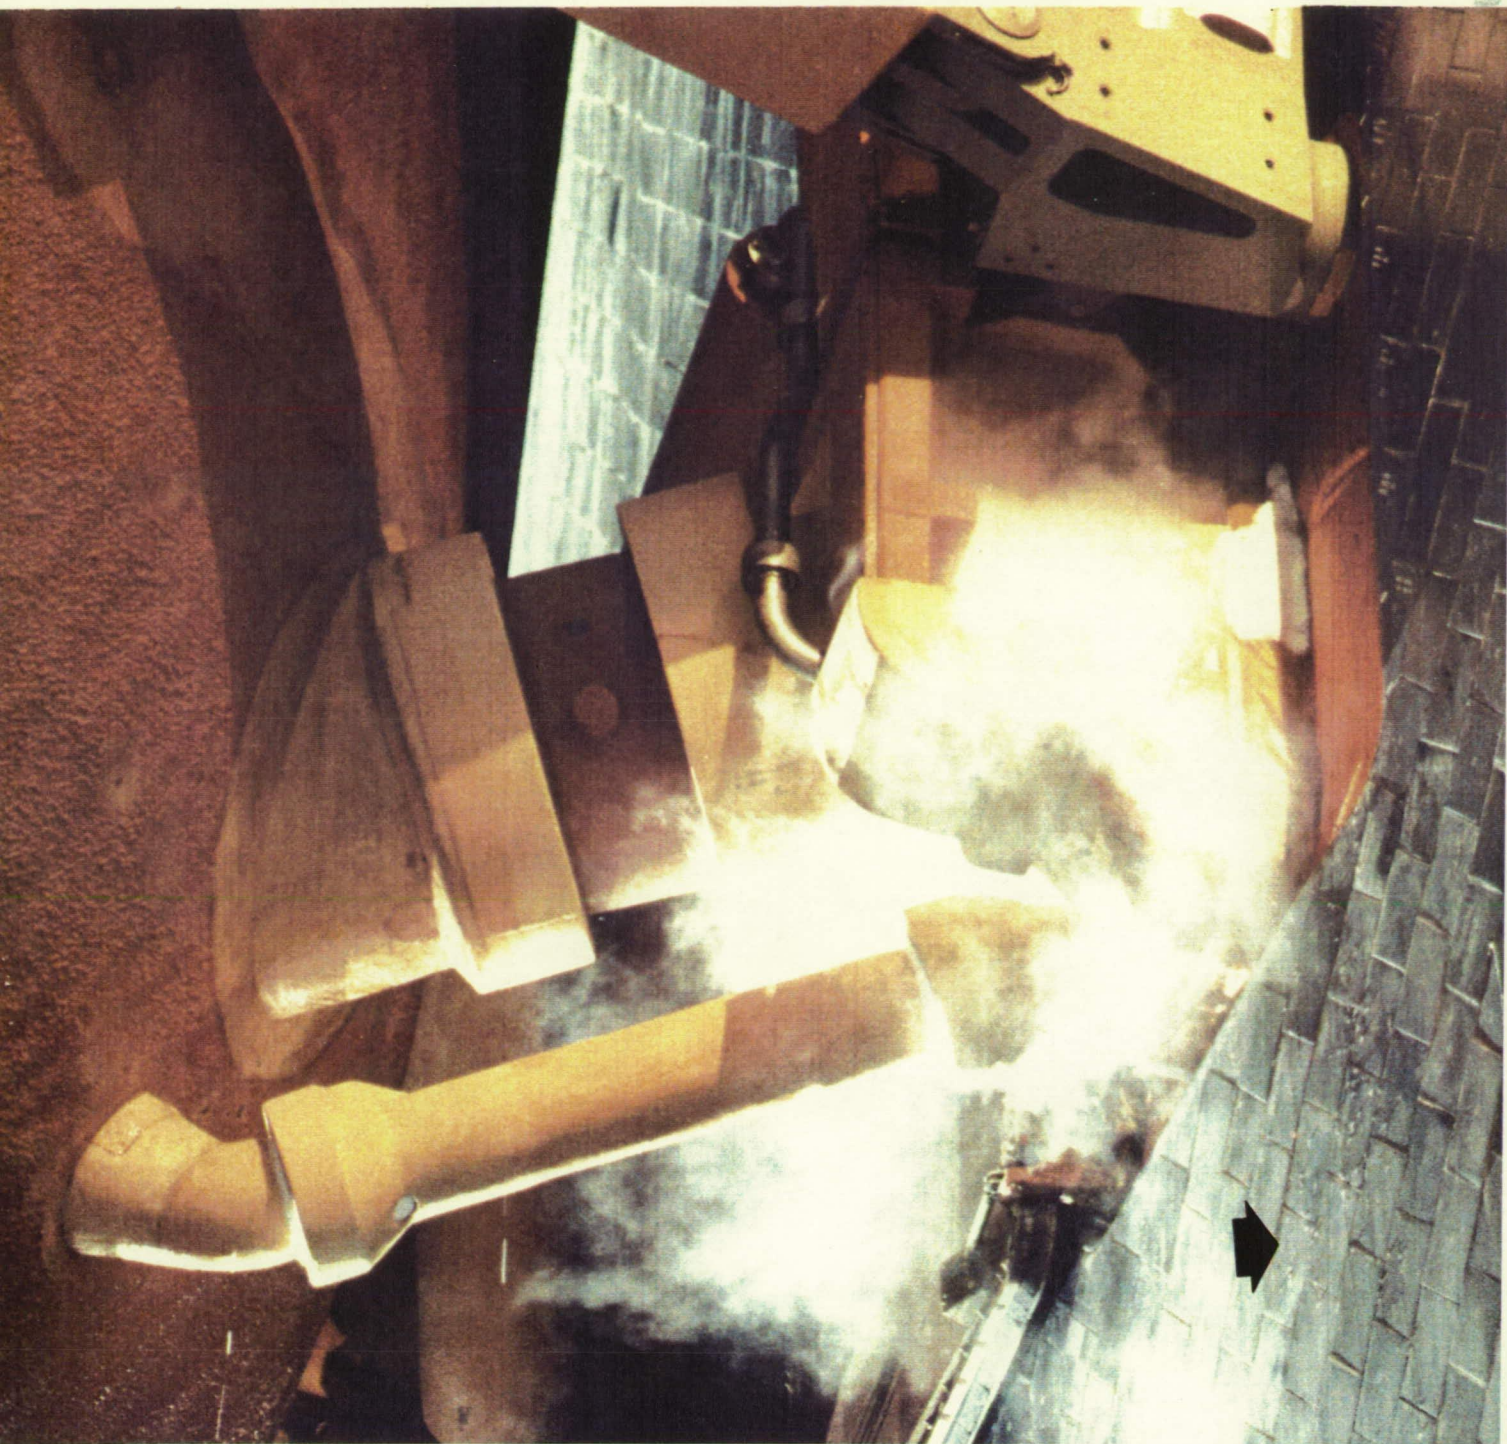
Atmospheric conditions (high humidity) caused condensate to drip from the LH2 ET/ORB umbilical onto Orbiter tiles. Normal venting of cold helium purge gas, more visible than usual, occurred during tanking, stable replenish, and launch.
